# **Kütahya Health Campus Project**

Environmental and Social Construction  
Monitoring Report - November 2022 Progress

January 2023

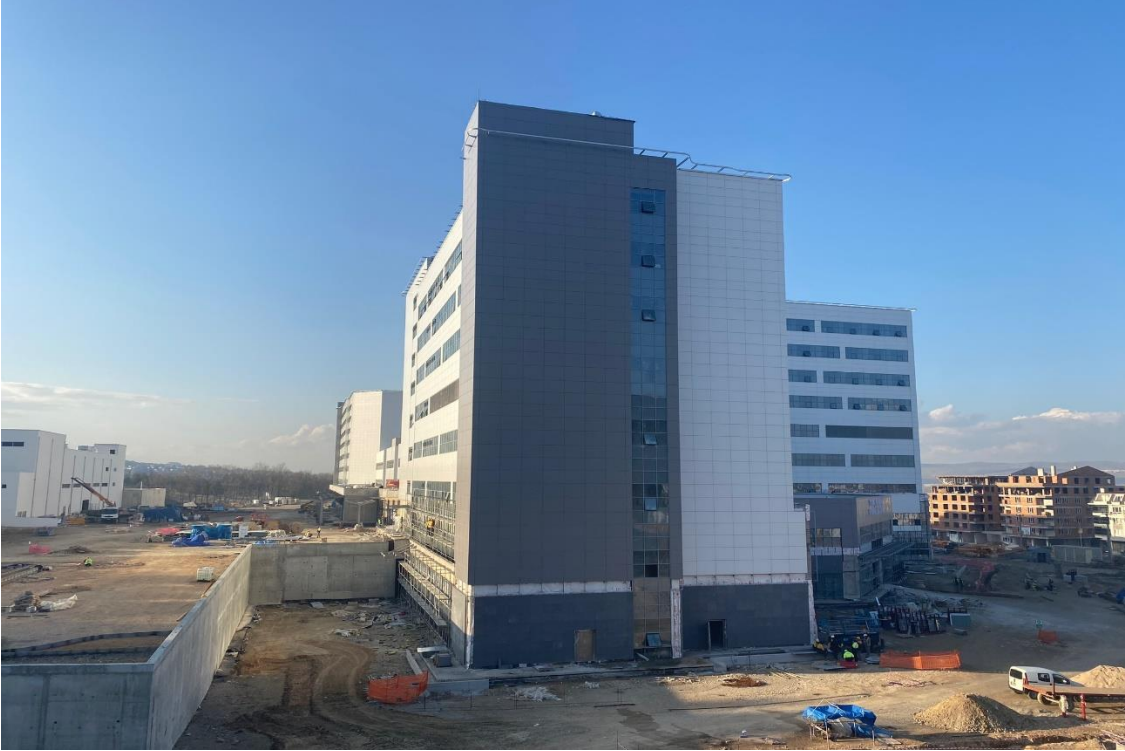
**Photo 1 General view from General Hospital Building Construction**

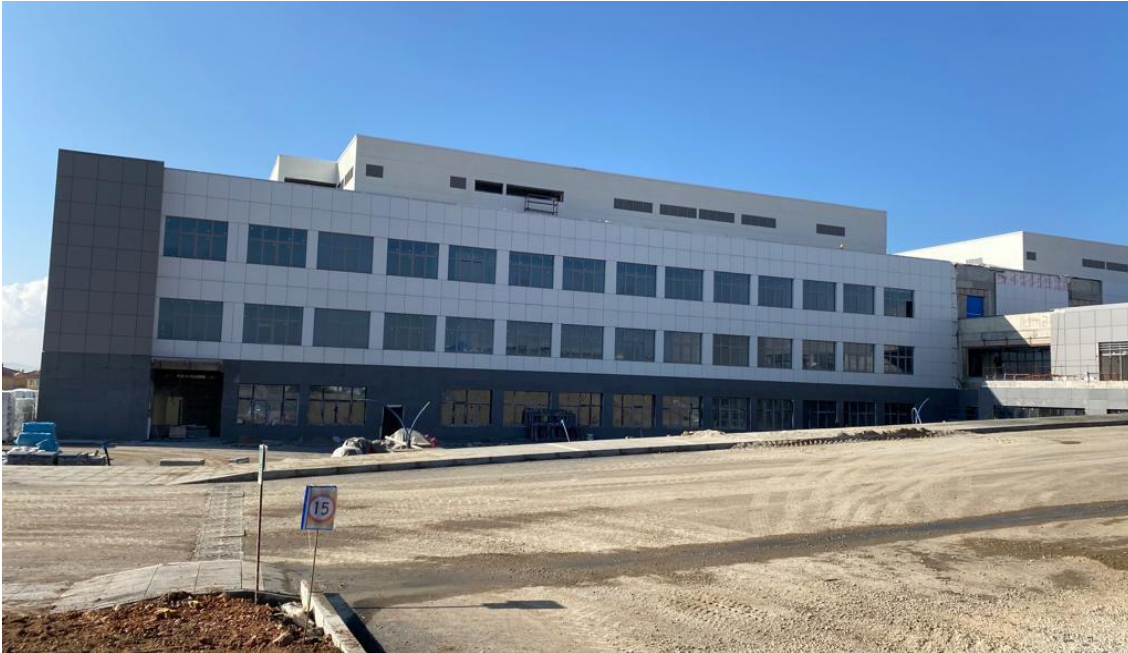
**Photo 3 General view from PTRH Building Construction**

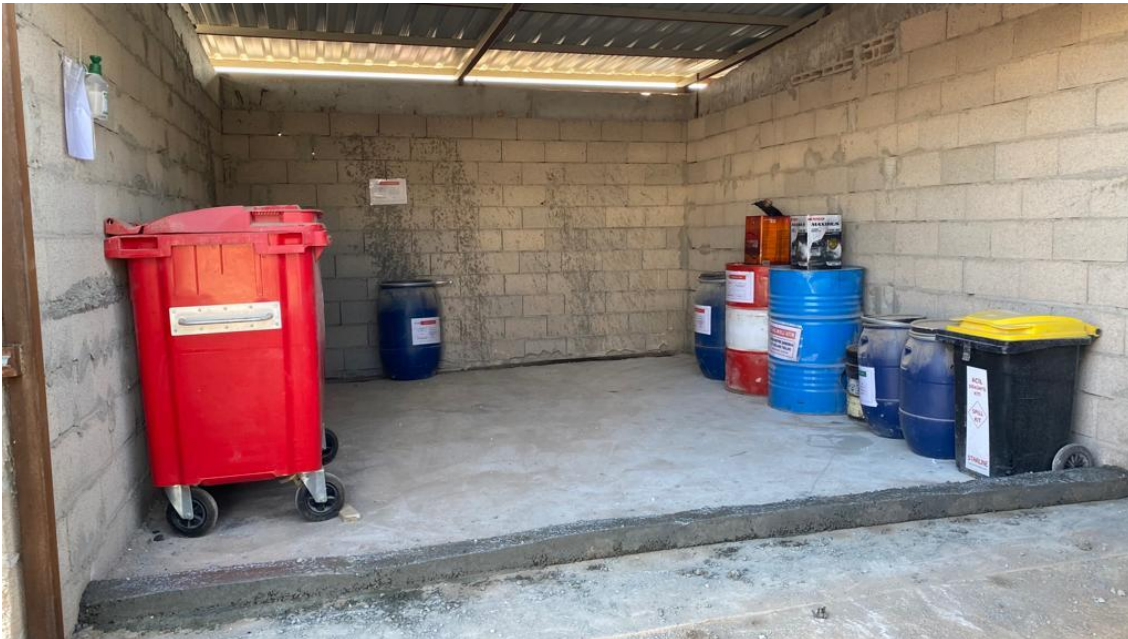
The EPC Contractor constructed a temporary waste storage area at both sites. An additional waste storage unit is present at the food production (kitchen) area located in the vicinity of workers' accommodation compound, managed by the sub-contractor for catering services. The wastes were segregated in specific waste streams, as set out in the national legislation. Inside the buildings where the construction is ongoing it was observed that the waste management and housekeeping were good.

**Photo 4 Hazardous waste storage area**

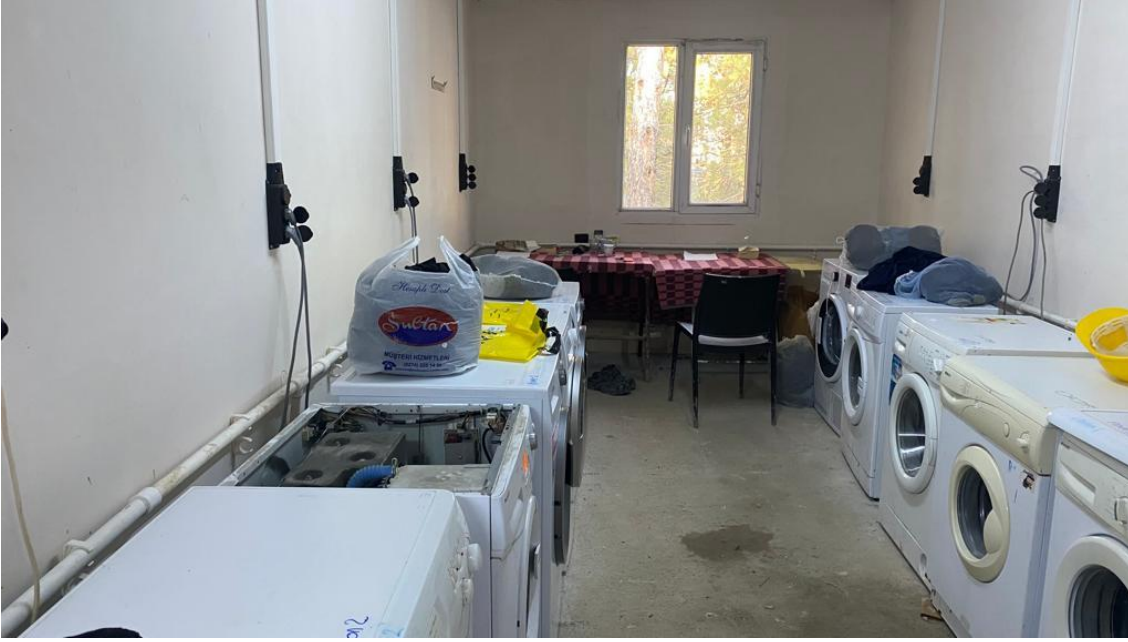
During the site visit, it was observed that the construction of the laundry building was finished, and it is located near the accommodation compounds. The EPC Contractor employed two personnel for laundry operation. Subcontractor companies have their own washing and drying machines. Workers leave their laundries in the morning and receive them clean and dried. During the site visit, MMT observed that the laundry detergents are not kept in air-tight containers; therefore, detergent smell was dominant in the building. Ventilation of the building was insufficient.

**Photo 5 Laundry Building**

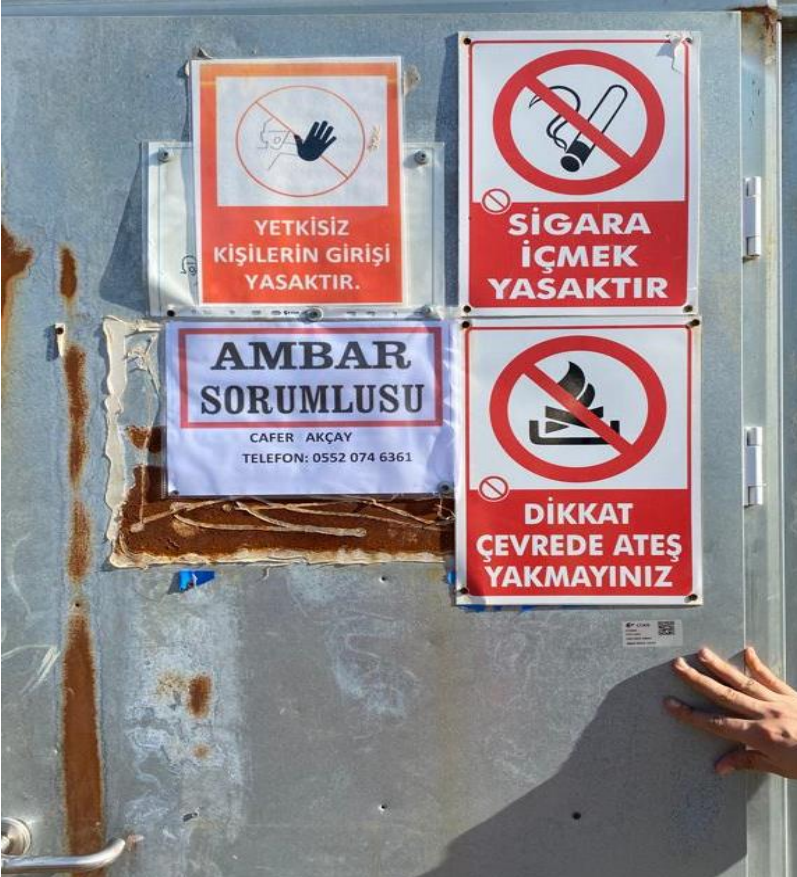
As part of project specific ESMS, Hazardous Materials Management Plan was developed. In the hazardous material storage areas, eye showers and spill kits were present but there were no heat sensors or smoke detectors installed in the storage areas. In the hazardous material storage areas SDSs were provided however in the construction areas where the chemicals are used there were no SDSs. In addition, it was observed that the chemicals are stored in the construction site without any label.

**Photo 6 The warning signs on the door of the chemical storage area in PTRH**

- SDSs should be present in the construction areas where the chemicals are used.
- During daily HS walkovers, hazardous material management in the construction areas should be strictly inspected.
- Smoke detectors or heat sensors should be placed in the hazardous material storage areas.
