Kütahya Health Campus Project

Environmental and Social Construction
Monitoring Report - December 2022 Progress

February 2023

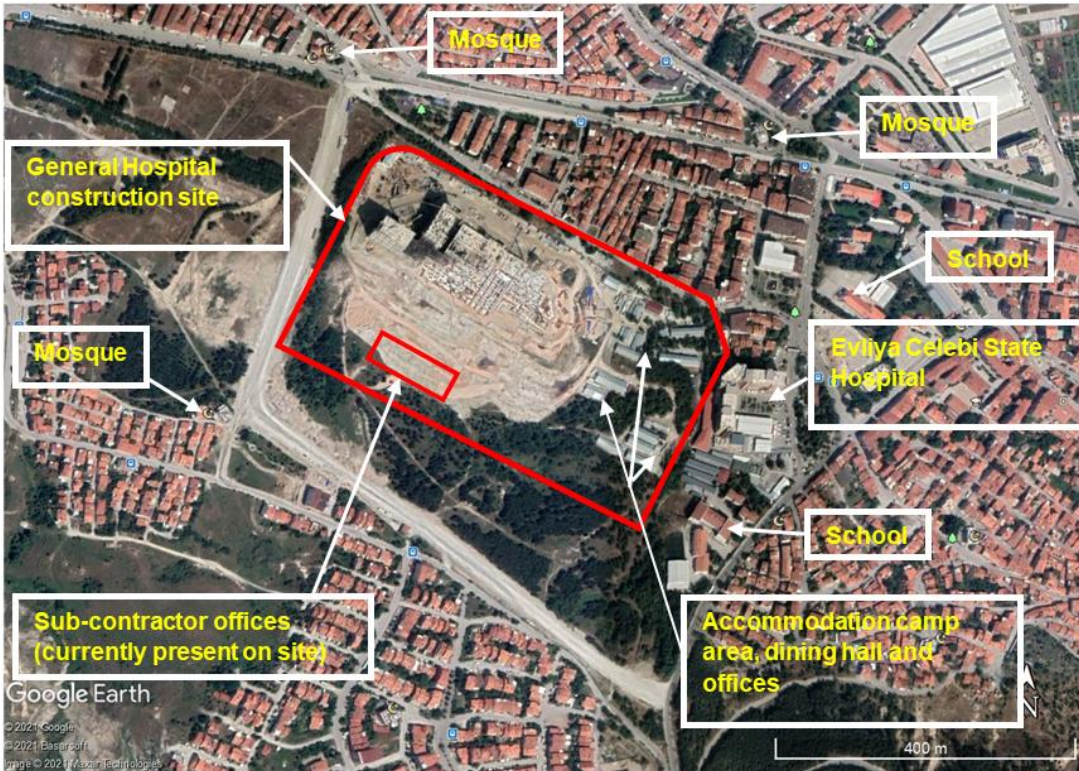
Figure 1-2 Aerial View of General Hospital Construction Site at Kütahya City Center

The General Hospital site is located in the Kütahya city center, which supports principally residential areas and commercial units. The closest neighbouring settlements are Evliya Çelebi to the north at approximately 40-50m, Okmeydanı to the south at approximately 250m and Gültepe to the southeast at approximately 650m distance to the Project site boundaries². The close vicinity of the Project footprint supports housing units, educational facilities, hospital facilities, businesses (pharmacy, supermarket etc.), mosques and recreational areas. Kütahya Anadolu High School and Hekim Sinan Vocational and Technical Anatolian High School are located approximately 100m (to the southeast) and 200m (to the northeast) distance to the Project site boundaries, respectively. Additionally, there are also three mosques which are located at approximately 120m (north), 150m (southeast) and 250m (northeast) distance to the Project site which are also illustrated in Figure 1-2.
