Kütahya Health Campus Project

Environmental and Social Construction
Monitoring Report

December 2022

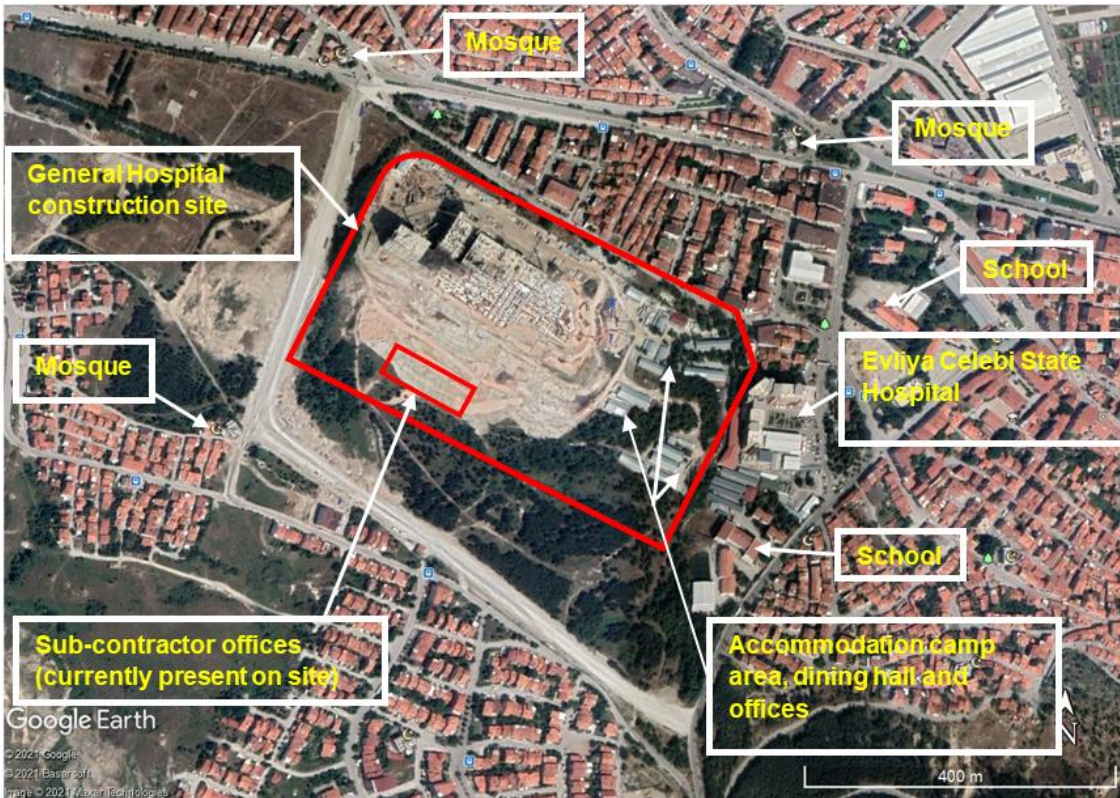
Figure 1-2 Aerial View of General Hospital Construction Site at Kütahya City Center

The General Hospital site is located in the Kütahya city center, which supports principally residential areas and commercial units. The closest neighbouring settlements are Evliya Çelebi to the north at approximately 40-50m, Okmeydanı to the south at approximately 250m and Gültepe to the southeast at approximately 650m distance to the Project site boundaries². The close vicinity of the Project footprint supports housing units, educational facilities, hospital facilities, businesses (pharmacy, supermarket etc.), mosques and recreational areas. Kütahya Anadolu High School and Hekim Sinan Vocational and Technical Anatolian High School are located approximately 100m (to the southeast) and 200m (to the northeast) distance to the Project site boundaries, respectively. Additionally, there are also three mosques which are located at approximately 120m (north), 150m (southeast) and 250m (northeast) distance to the Project site which are also illustrated in Figure 1-2.

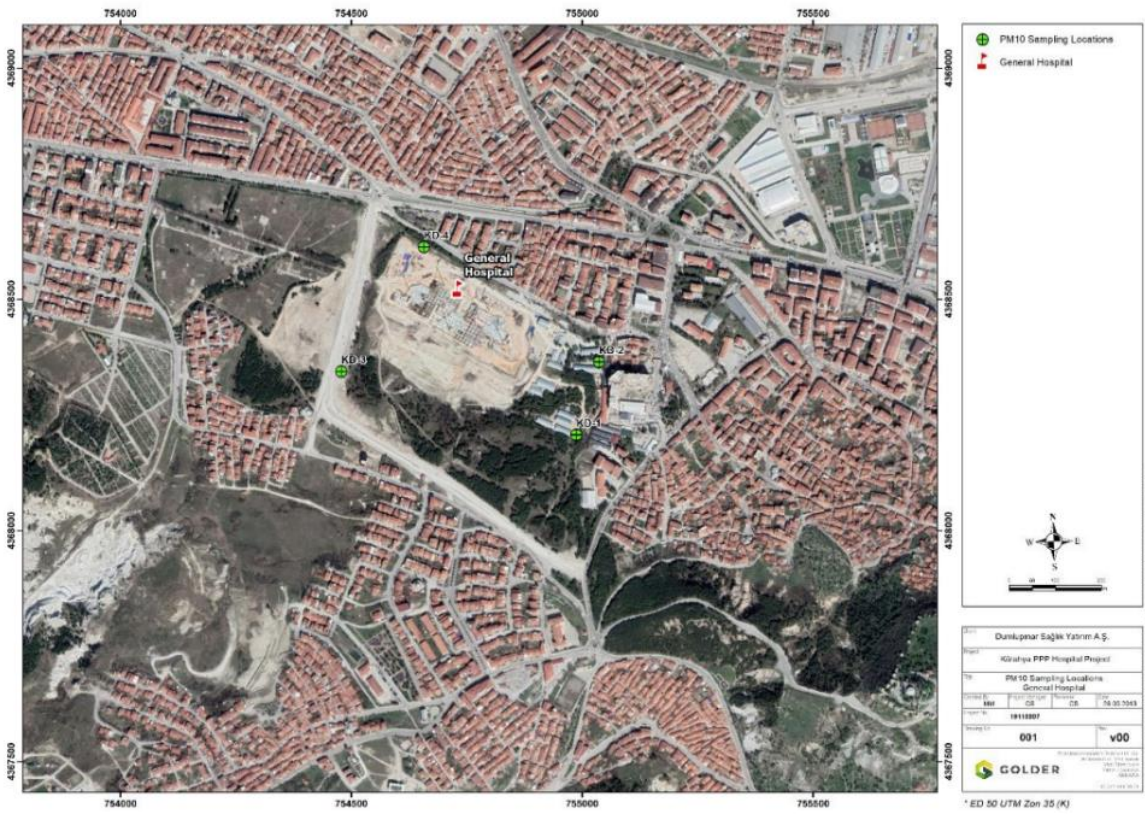
compliance with the local, IFC's, EBRD's requirements. Six monitoring points which are presented in Figure 2-1 PM₁₀ Measurement Points in the General Hospital Figure 2-1 and Figure 2-2 were selected taking into account the sensitive receptors identified and their distance and location with respect to the emission sources. According to Air and Noise Quality Monitoring Report issued in September and October 2022, PM₁₀ values which are between 23.7 – 26.2 µg/m³ and 22.1 – 25.3 µg/m³ do not exceed the limit values defined in the Turkish legislation, the IFC limit and EU limits.

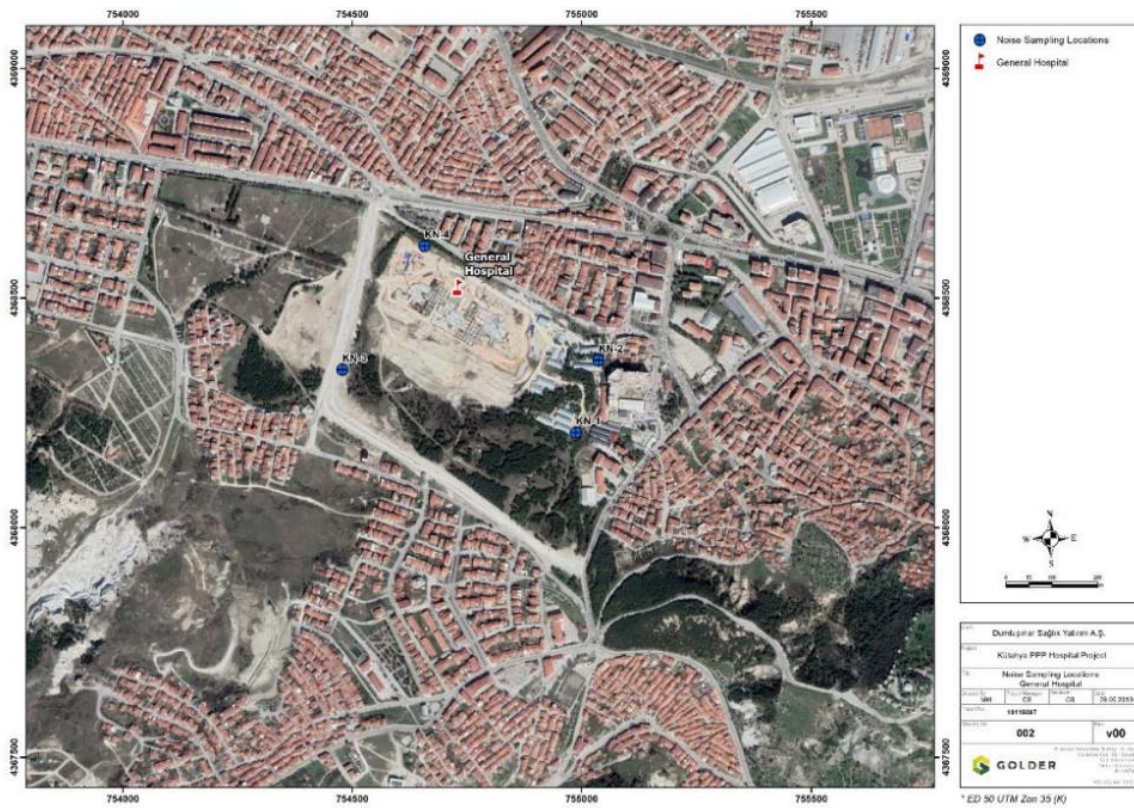
Figure 2-3 Noise Measurement Points in the General Hospital

Noise and Vibration Management Plan (NMP) has been developed as part of construction phase ESMS. Monthly ambient noise measurements have been conducted at six measurement locations which are presented in Figure 2-3 and Figure 2-4. (four measurement locations located approximately construction area borders in General Hospital, whereas two locations located approximately construction area borders at PTRH) since 2019. All measurement reports were reviewed by MMT.

According to Air and Noise Quality Monitoring Report issued in September 2022, noise measurements were conducted between 14 – 15 September 2022 (between 12:00 a.m. on 14.09.2022 to 11:45 p.m. on 15.09.2022), for duration of 48 hours. The same report is issued for October 2022. According to the measurements conducted between 18 – 20 October 2022 (between 12:00 p.m. on 18.10.2022 to 11:45 a.m. on 20.10.2022), for duration of 48 hours, all average measured noise values are below the limit values defined in the Turkish legislation and the IFC limits.

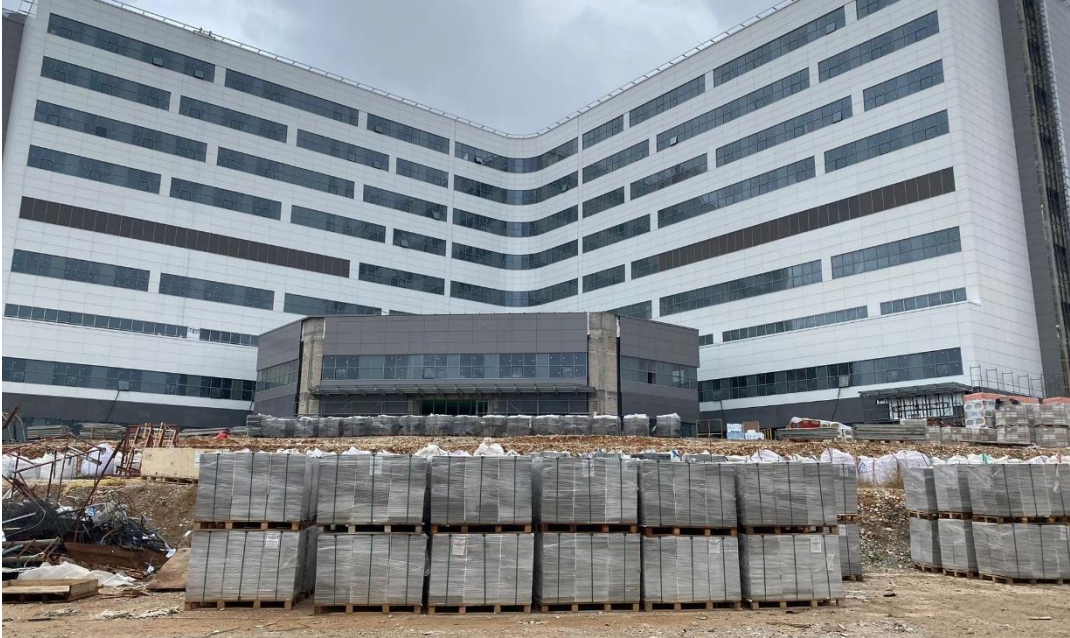
Photo 1 General view from General Hospital Building Construction

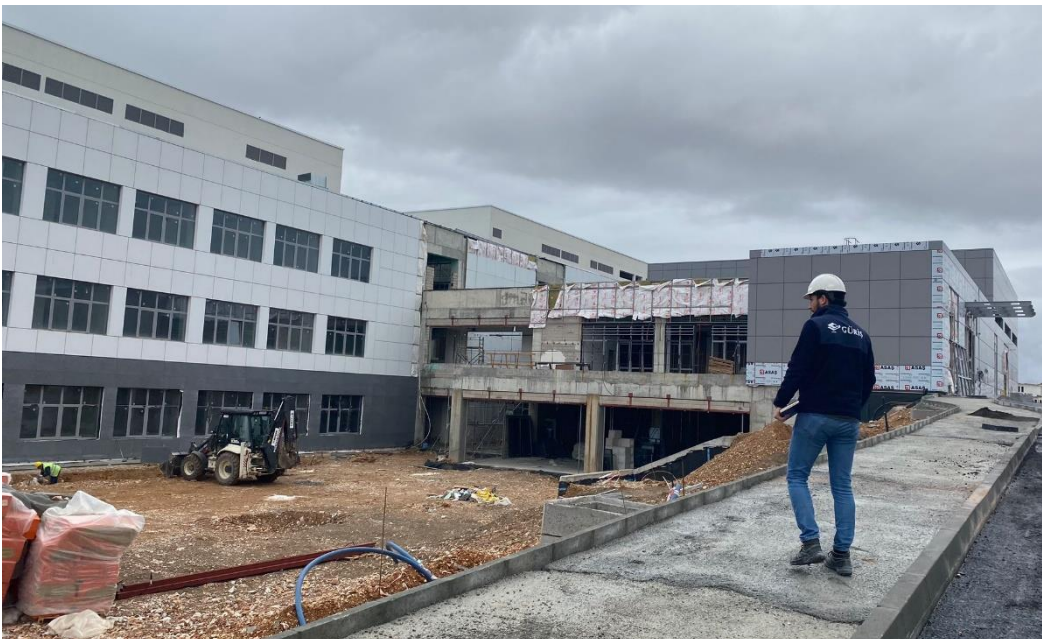
Photo 2 General view from PTRH Building Construction

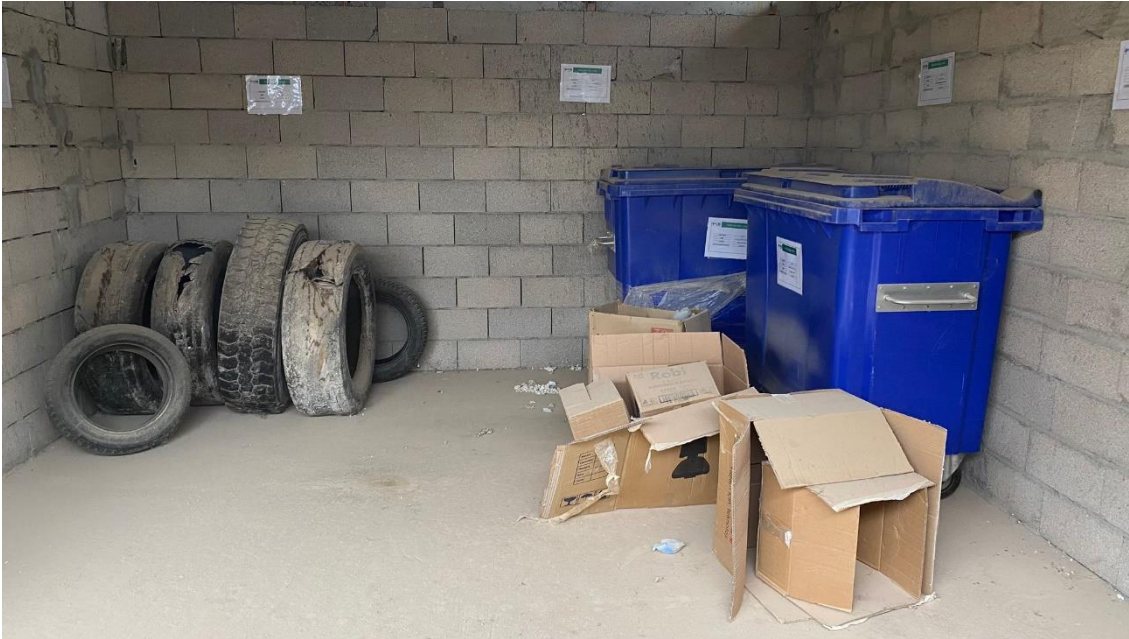
EPC Contractor constructed a temporary waste storage area at both sites. An additional waste storage unit is present at the food production (kitchen) area located in the vicinity of workers' accommodation compound, managed by the sub-contractor for catering services. During the site visit in November 2022, MMT observed in waste storage area that majority of the wastes were segregated in specific waste streams, as set out in the national legislation.

Photo 3 Non hazardous waste storage area

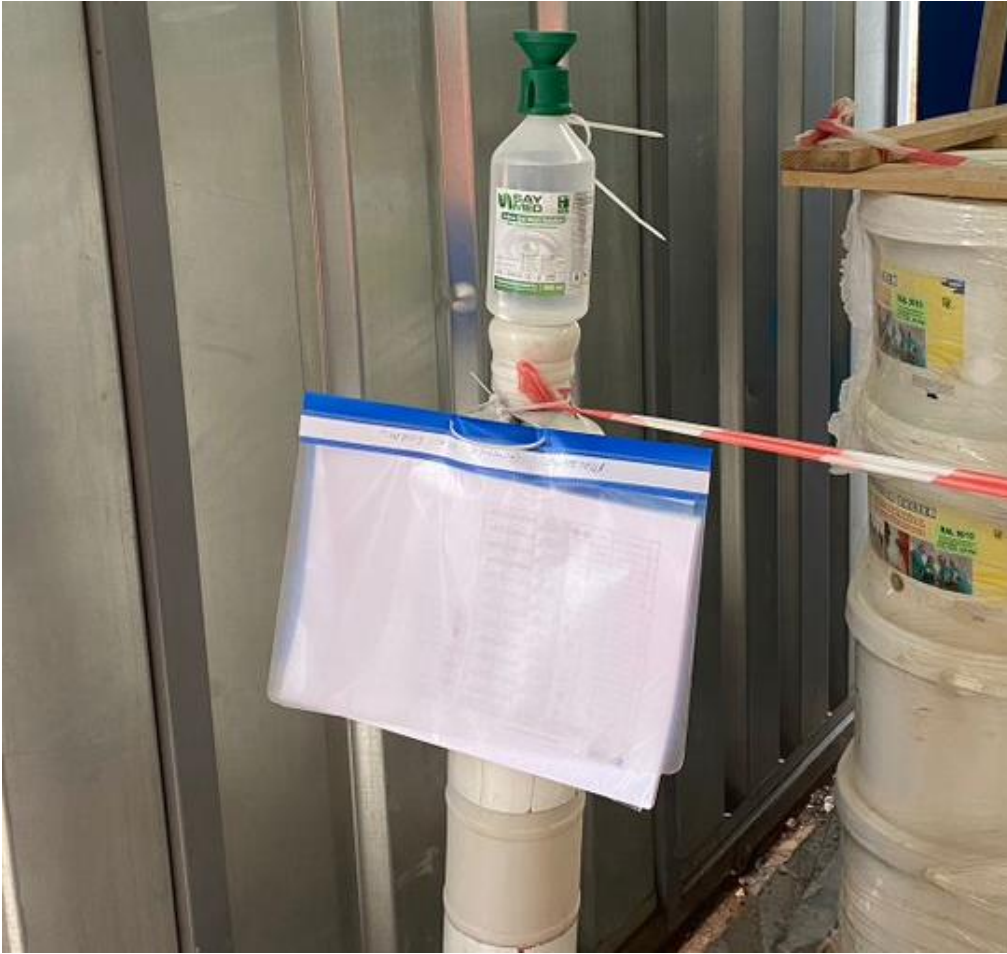
In the 1st Construction Monitoring Report, MMT suggested that eye showers and additional spill kits should be placed in hazardous material storage areas, and in this site visit, eye showers and spill kits were observed in the storage areas.

Photo 5 Eye shower in the chemical storage area
